The analysis of the main perturbing factors and the physical–chemical description of the Vâlsan hydrographic basin, in the conditions of year 2005

Alina – Mihaela Vlăduțu¹, Codruța – Mihaela Dobrescu¹, Gabriel Bratu¹

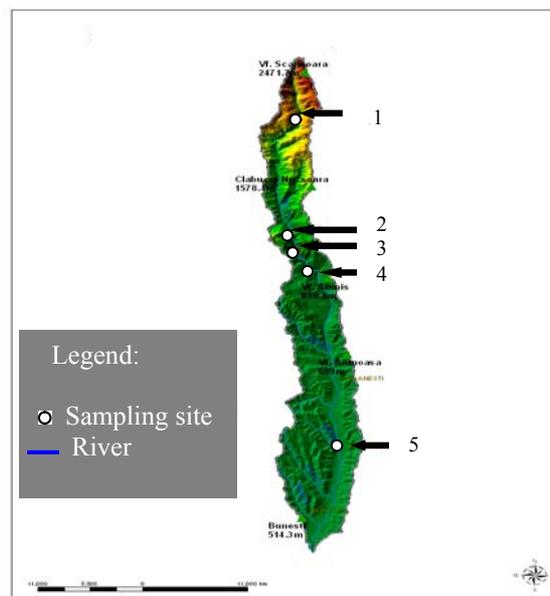
Figure 1. Sampling sites: 1.Upstream lake, 2. Vâlsan gorges entrance, 3. Vâlsan gorges exit, 4. Brădet, 5. Mălureni

The water samples were gathered in August 2005. Detailed sampling sites can be seen on Figure 1. In placing the stations the following criteria have been under consideration: influence of the hydro-technical planning; anthropogenic factor (disorganized tourism, rural planning); river ability of self-filtering and restoration.

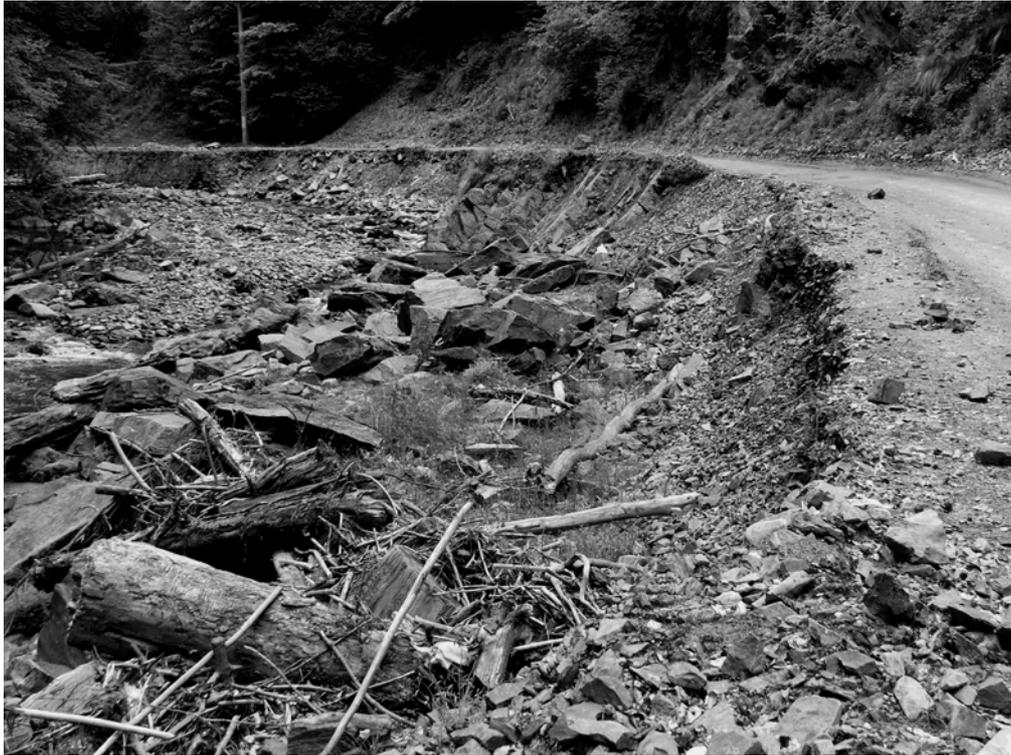
Figure 2. Vâlsan River – the riverbank eroded by the flooding

In 2005, the climate changes represented an important ecologic perturbing factor in the Vâlsan basin. The huge rain quantity caused freshet and torrents, which carried tree-trunks and stones downstream and eroded the riverbanks. This destroying effect was also enhanced by massive deforestation (Fig. 2 - 3).

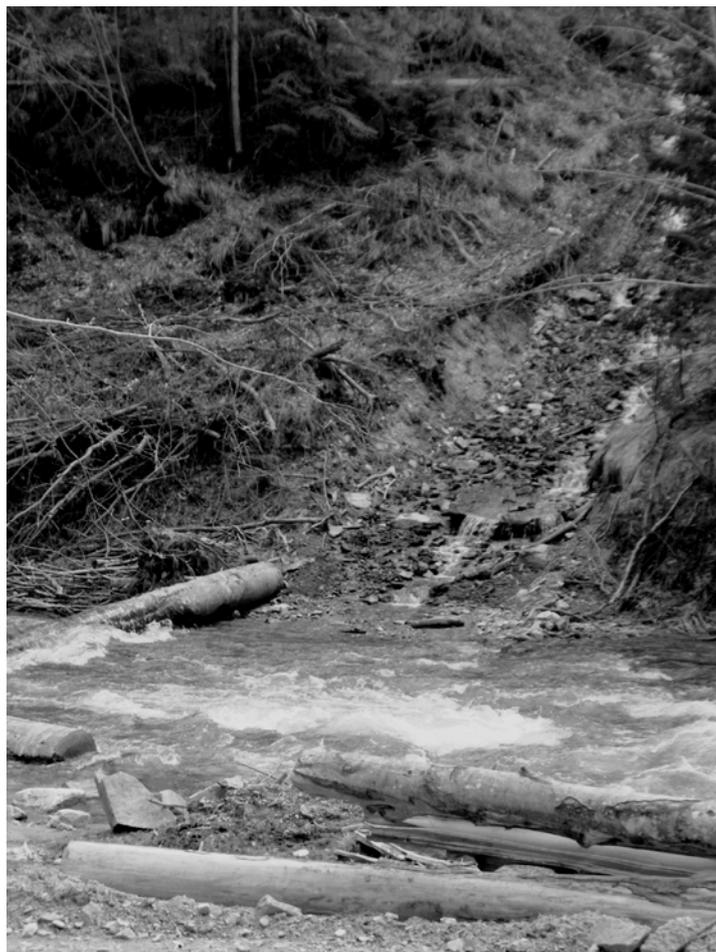
Figure 3. Vâlsan River after the freshets and torrents – August 2005
